Identification of mine subsidence on aerial photographs in central Illinois

Philip J. DeMaris
Robert A. Bauer

November 1983

Illinois Department of Energy and Natural Resources
STATE GEOLOGICAL SURVEY DIVISION
Champaign, Illinois

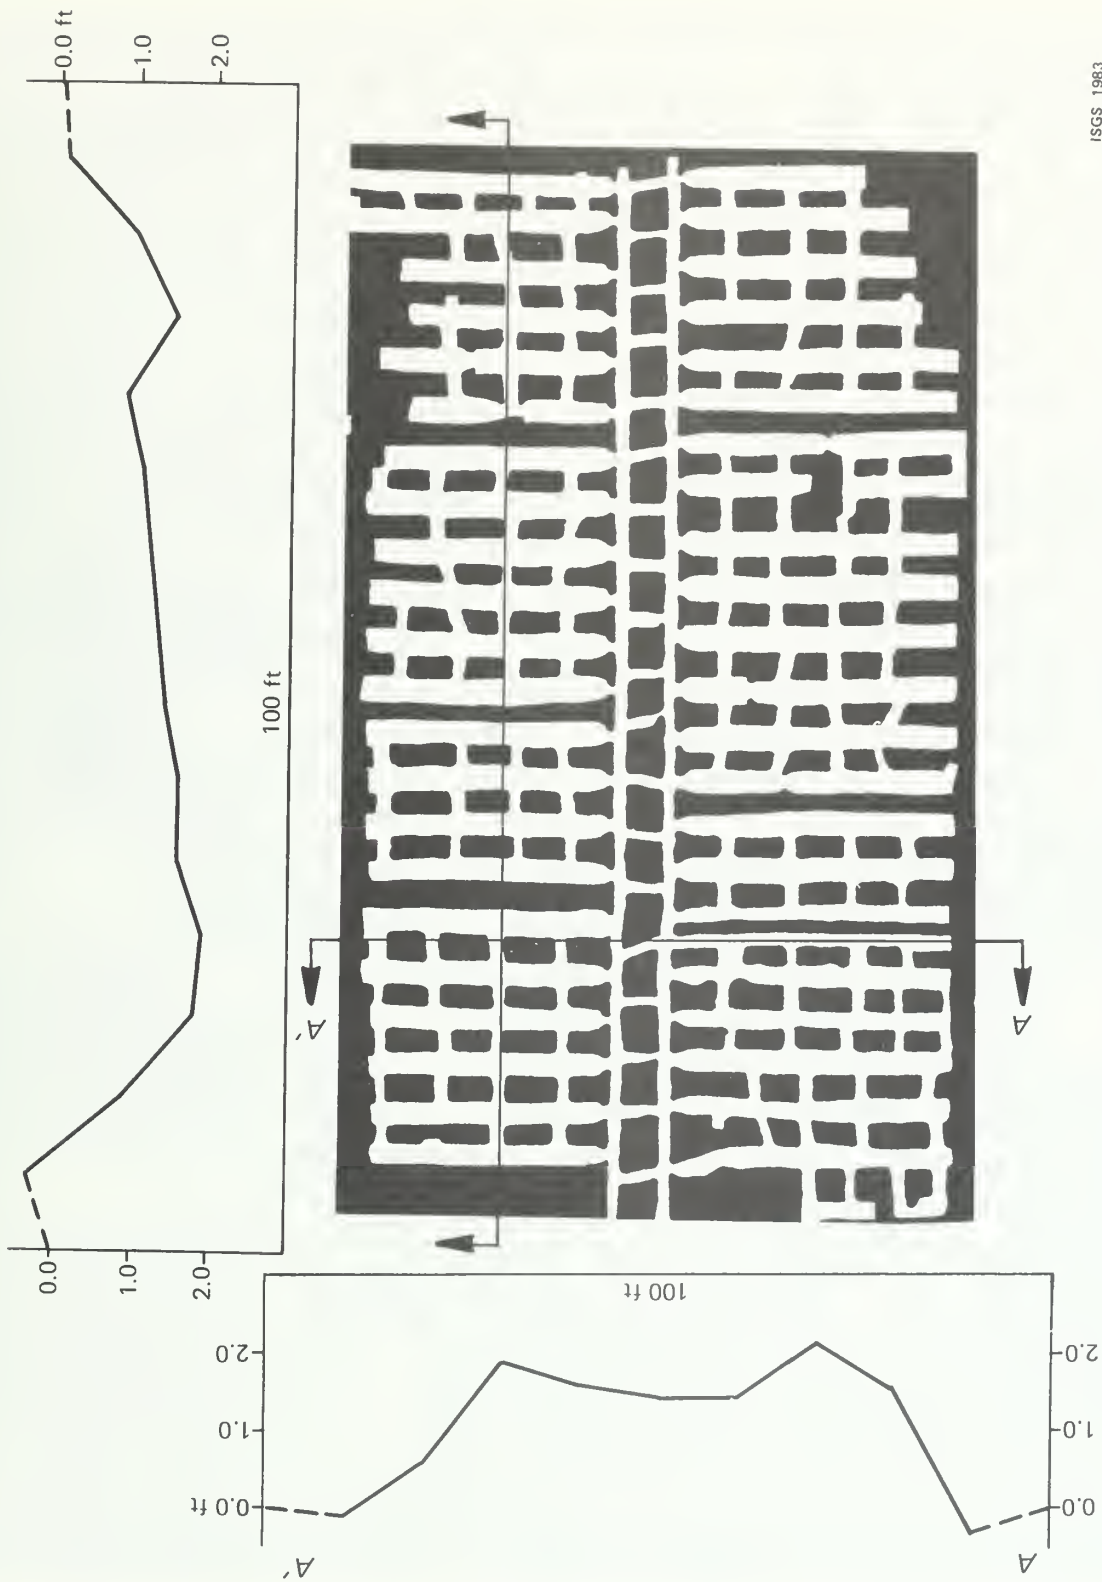
The largest and best documented anomaly (site 43) had repeated crop problems. Surveys of this area during and after subsidence showed a 2.1 feet drop at the lowest point, and a 1.5 feet drop covering a large area. The initial survey was probably performed after some movement had already taken place; the initial survey apparently followed recognition of some surface drop. Four sets of photographic coverage showed moderate to serious crop loss caused by spotty to total failure in germination within the lowest areas within site 43 (large area of subsidence at south end of study area, figs. 5, 6, and 7). Aerial photography during the 1970s indicates that the roughly 20 acre block

around site 43 was no longer planted in corn. Field checks during the spring of 1980, 1981 and 1982 showed substantial ponding. We do not know if field tile was used or if an attempt was made to drain site 43.

Figure 4. Map and subsidence profiles of production panel in No. 6 Mine of Madison Coal Corporation, site 43 (based on survey by Quade, 1934).

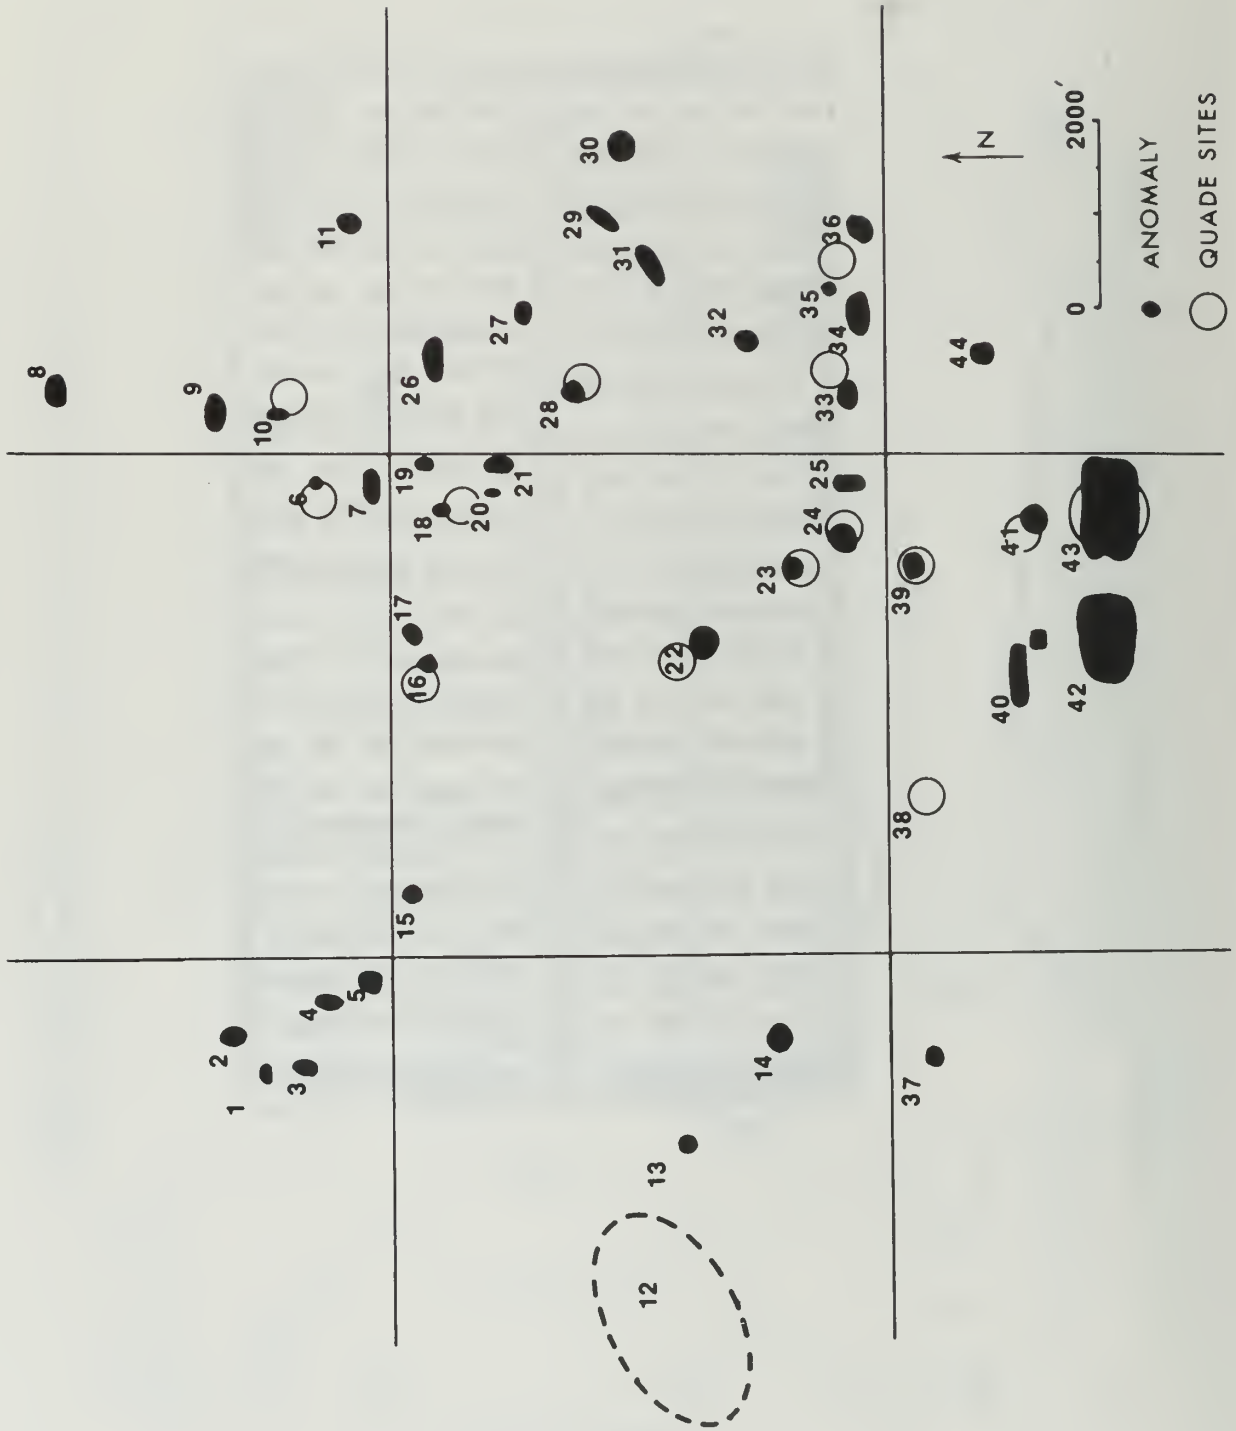
Figure 5. Location and number for sites located on stereo pair aerial photographs of the Divernon area.

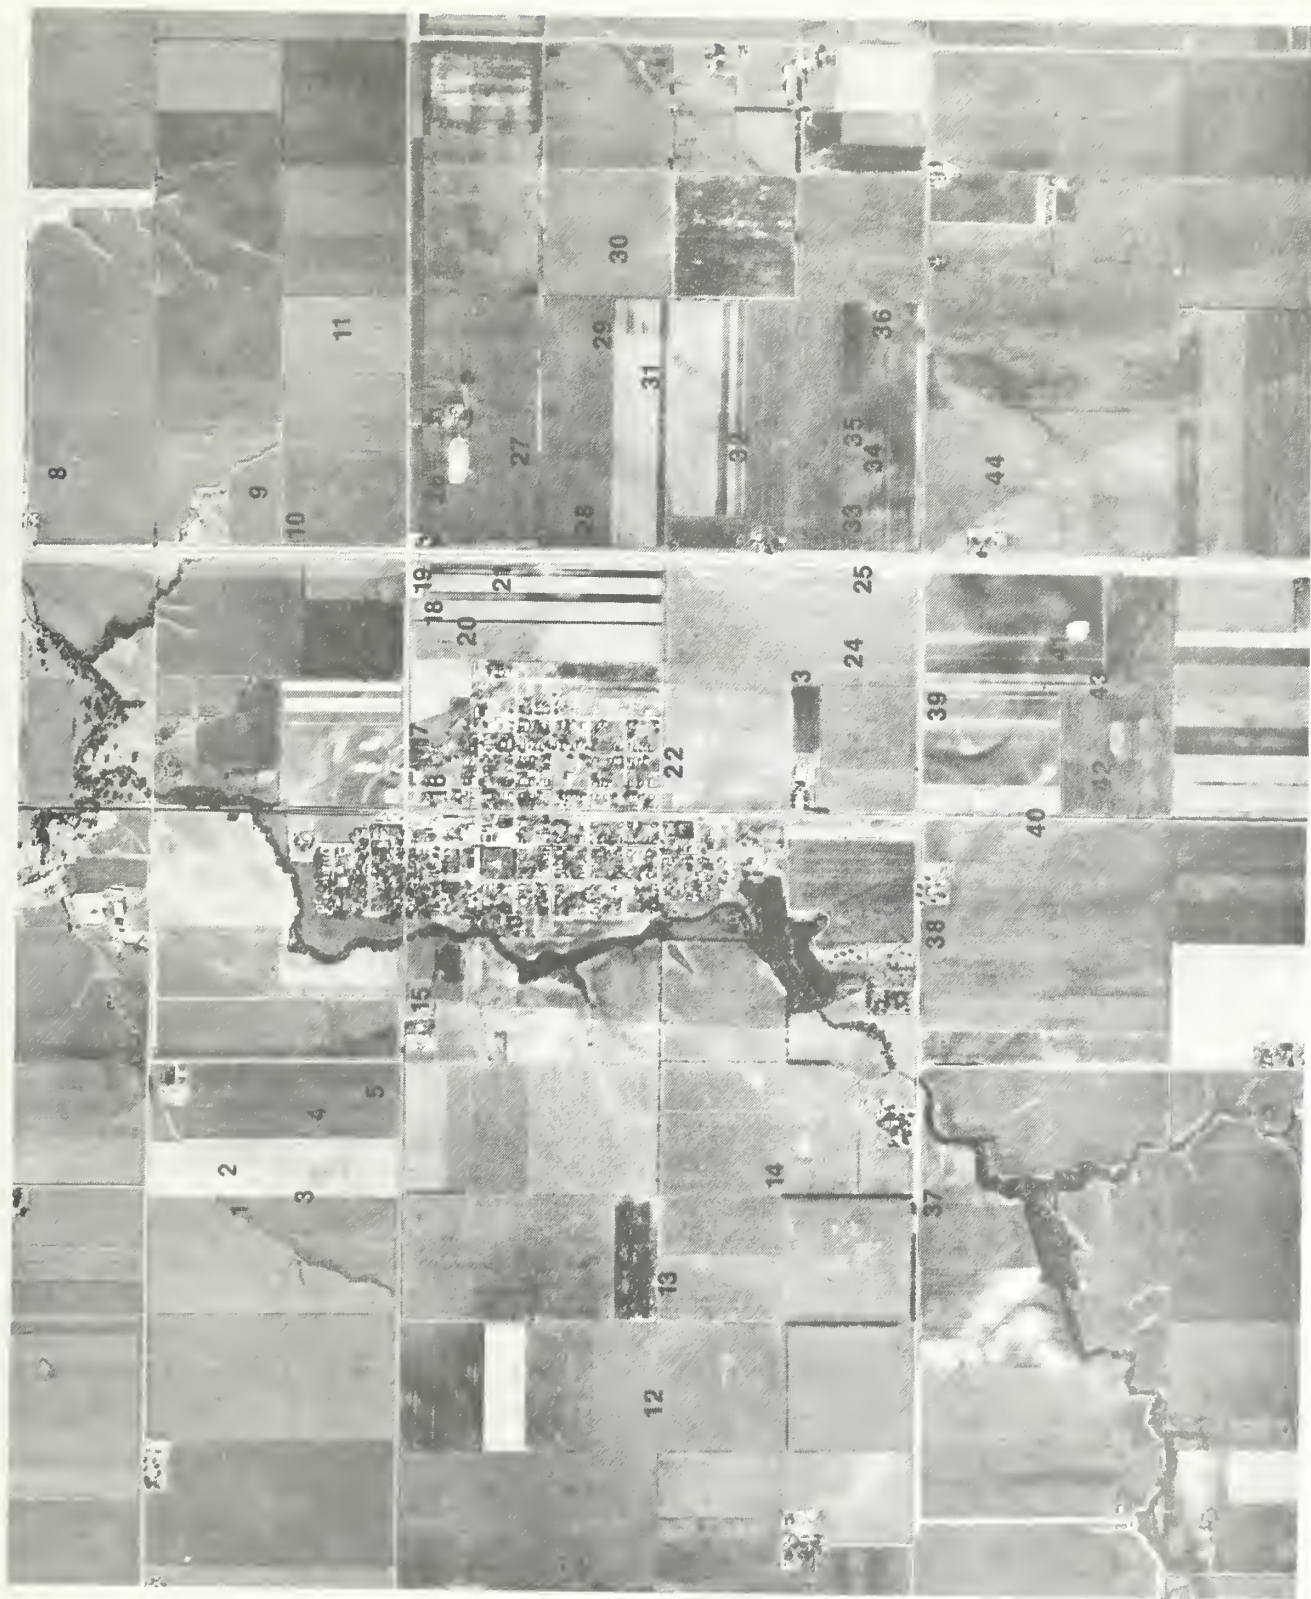
Site-Specific Evaluation. Forty-four sites in the Divernon area were studied on the sets of aerial photographs (fig. 5 and 6). All air photo anomalies and reported sites in or within about one-quarter mile of the general mapped boundary of the mine were considered for this study. Table 1 shows the disposition of the indicators for each site on the various sets of aerial photographs. Each site is categorized for each set of photographs as 1) "Positive" - the site showed some topographic, tonal or textural indication on a set of photos; 2) "Neutral" - the site was altered or obscured on a set of photos; or 3) "Negative" - the site was not found on a set of photos. The positive indicators were subdivided into "weak" and "strong" categories on the basis of how strong the visual contrast was between the site and the normal tonal, textural and topographic variations. Positive and negative indicators for each site were then compiled for use in the analysis (table 2). Also on table 2 are notes on each site concerning their persistence amongst sets of air photos, overall strength of indicator, and other observations.

Figure 6. Mosaic of aerial photos showing location of anomalies.

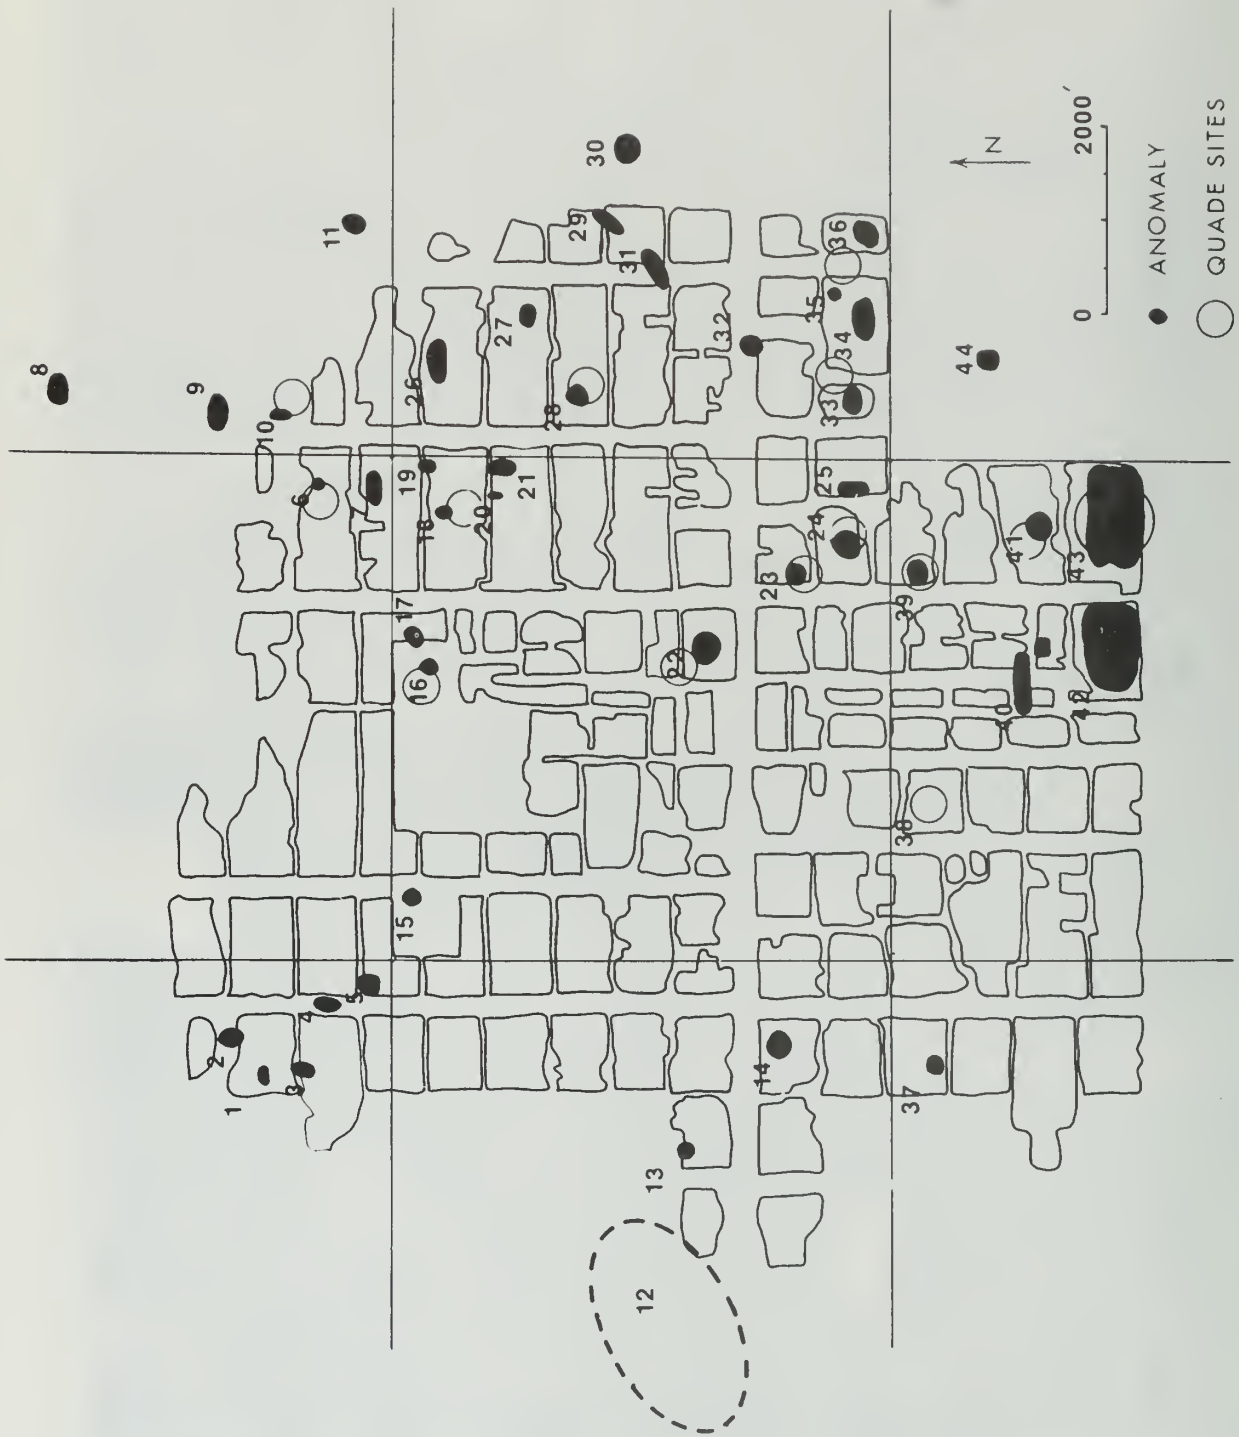
properly over production panels of the mine (table 3, fig. 7). Of these 28 sites, 13 are subsidence sites designated by J. C. Quade's report or areas marked on the mine map where squeezes had taken place in the mine (table 3).

The southeast portion of site 40 is located over very large chain pillars along the haulageways in the production panel. The production part of this panel is only the southern 2/3 of the outline shown in figure 7. The haulageways are the northern part of the panel.

Figure 7. Anomalies and Quade subsidence sites superimposed over outlines of mine production panels.
